# REPORT

## Geotechnical Inspection Reach 8 Chainage 400-500m Henderson Creek, Waitakere City

42088696/R023

Date: **28 July 2005**  
Reference: 42088696/R023  
Status: Rev.0

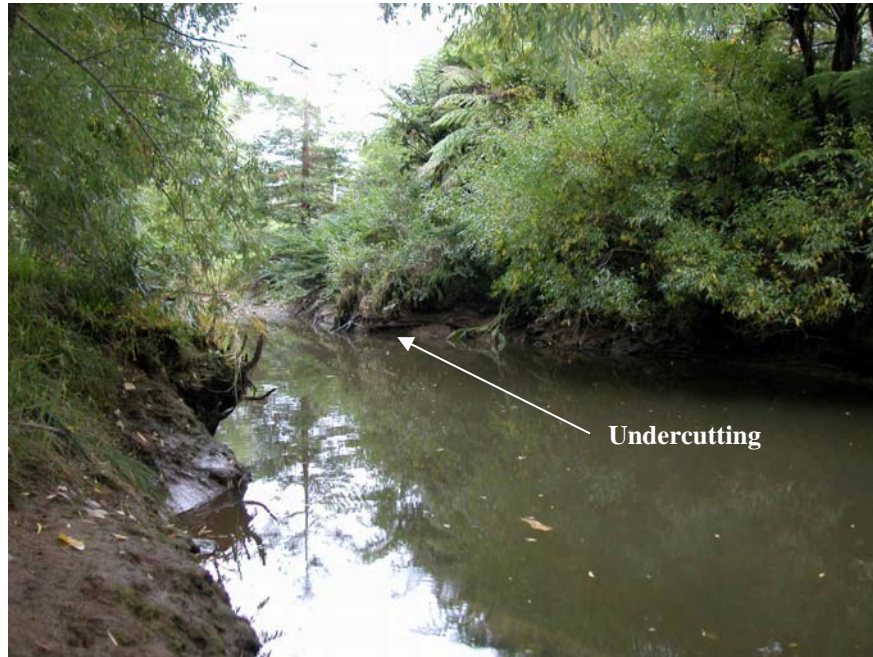
**Figure 2** Upstream view of streambank Reach 8 Ch 400 on the right hand side.

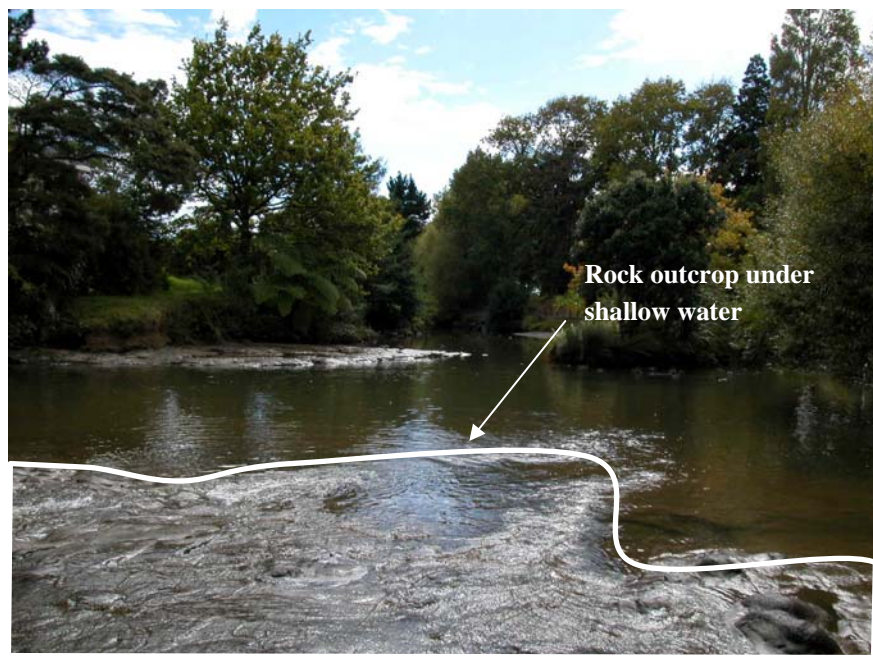
The streambank at this location consists of a generally flat to moderately dipping ( $< 30^\circ$ ) slope, although the 1m to 2m high stream scarp is steep ( $60^\circ$ ) to sub-vertical. The slope is primarily grass covered, although a variety of shrubs and trees form a line along the stream scarp between Ch400 and Ch440m (Figure 2). Undercutting of the slope is limited to the downstream section i.e. Ch 400 (see Figure 2). Rock of the Waitemata Group outcrops within the streambed and lower banks, particularly upstream near the Sel Peacock Drive Bridge (Figure 3). The stream varies significantly in width, from approximately 5m to 20m.

**Figure 3** Downstream view of streambank Reach 8 on the left hand side from Sel Peacock Drive bridge.  
Rock outcrop is under the shallow water.

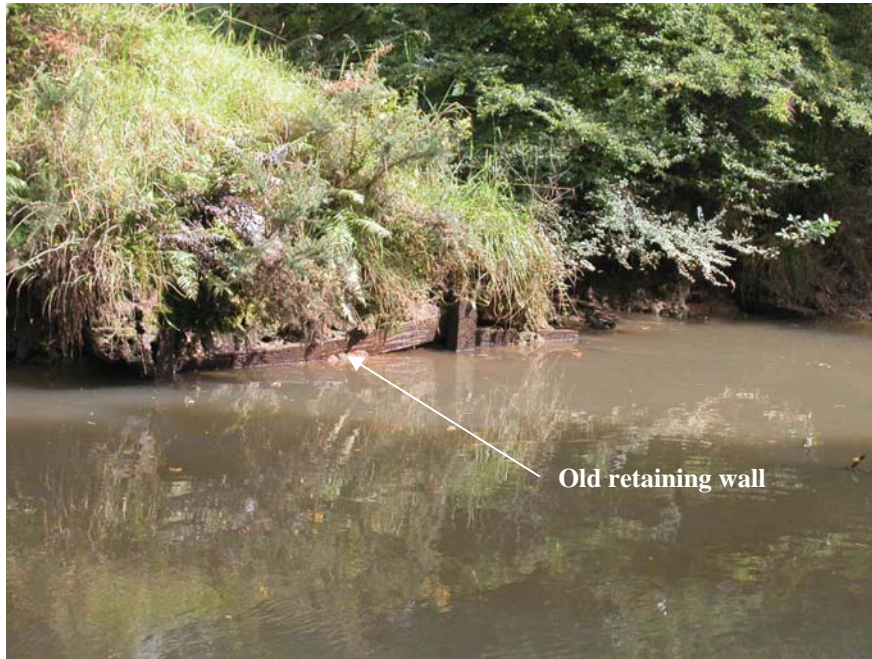
The presence of a damaged retaining wall structure at Ch450 placed this site within the high hazard category in the URS 2004 study. This wooden retaining wall is in a poor state of repair and exhibits significant outwards bending and tilting (Figure 4). The nearest other structure is a building located approximately 10m back from the top of the streambank.

Deformation within the existing retaining wall indicates that the streambank is failing, albeit slowly. No other areas of instability were noted, apart from some undercutting of the streambank soils near the waterline. Long-term stability of the retained slope will require the replacement of the existing structure, preferably with one founded in the underlying Waitemata Group rocks. It is expected that without replacement, the existing retaining wall will fail. Although this will not represent any direct hazard to adjacent structures, it will result in ongoing deposition of sediment into the stream.

**Figure 4** Old retaining wall on Reach 8 Ch450

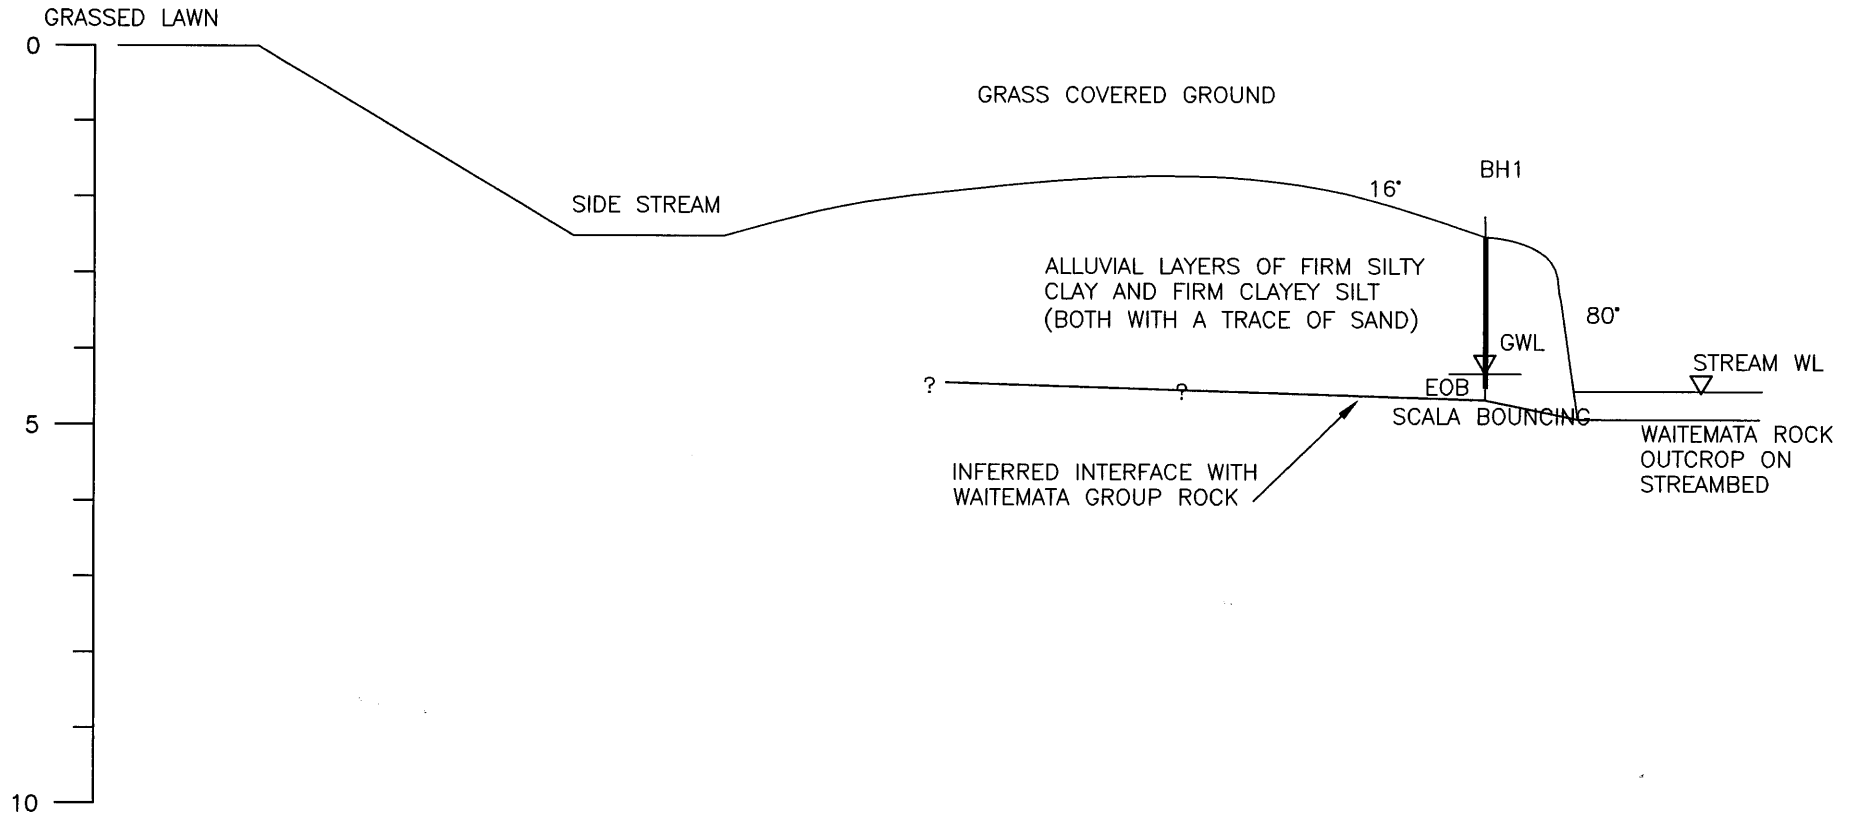
**FIGURE A-2**

The investigation indicates that the streambank comprises topsoil overlying approximately 2m of firm silty clay and clayey silt with a variable sand content. These materials are believed to be of alluvial origin (i.e. Puketoka Formation). Undrained shear strengths measured within the borehole ranged from 30kPa to

45 kPa. Penetration refusal was inferred to represent the top of the Waitemata Group rock. The very rapid transition from alluvial soil to rock indicates that erosion had removed the residual soil developed on top of the Waitemata Group prior to the deposition of the Puketoka Formation.

**GEOLOGICAL CROSS SECTION  
REACH 8 - CHAINAGE 455**
