Project Twin Streams

REPORT CARD 2016

Working together for healthy
streams and strong communities

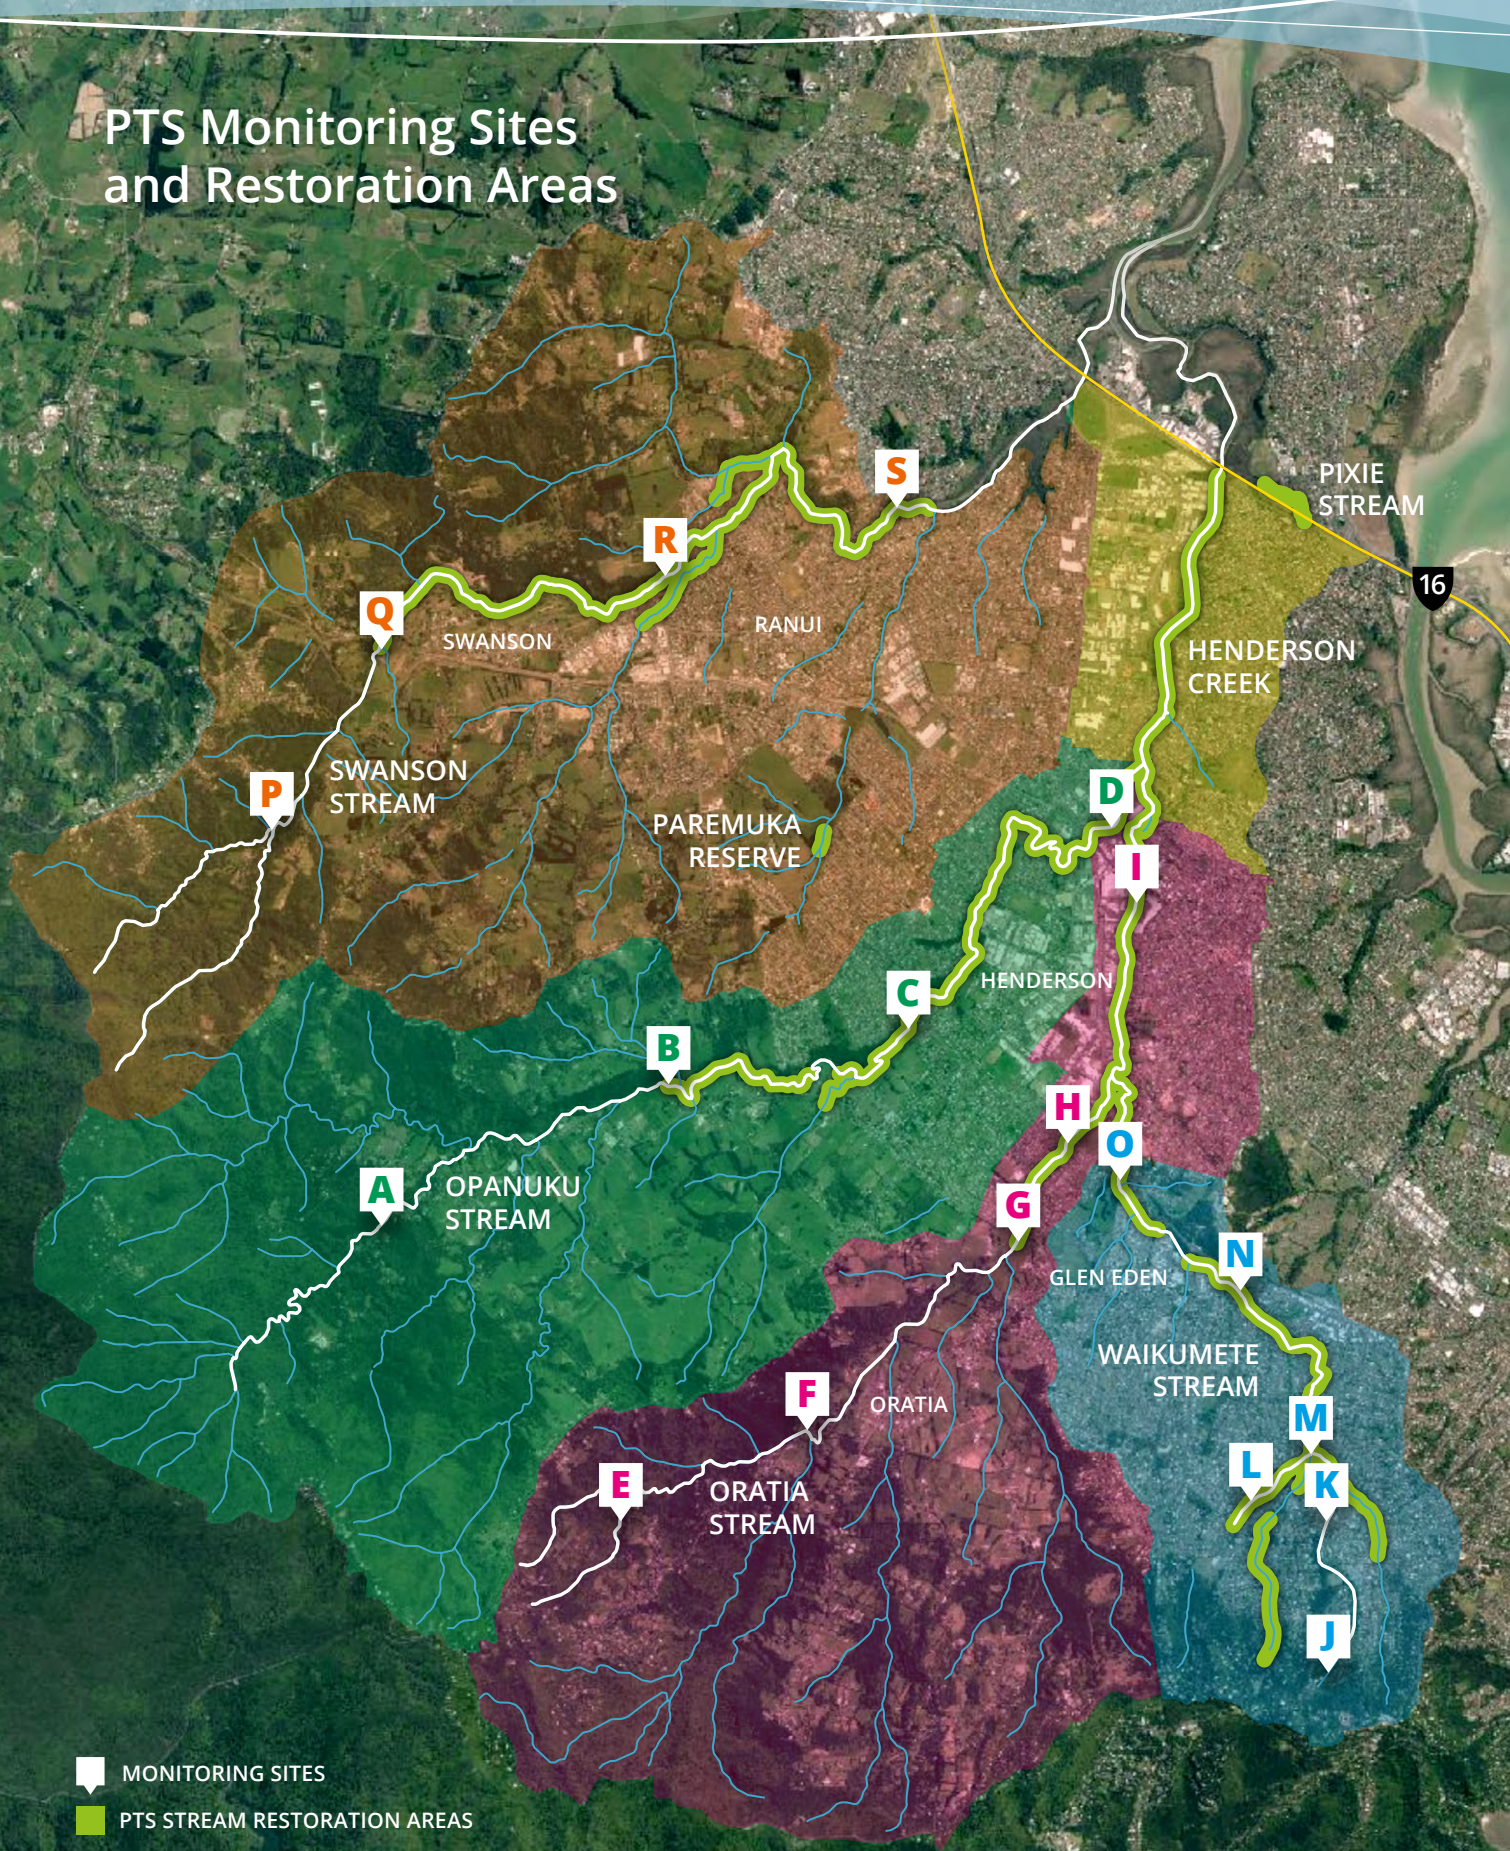
FIGURE 1: PTS Catchment:
Monitoring Sites and Restoration Areas

PTS monitoring focuses on whether its streams are supporting a healthy ecosystem. Nineteen water quality monitoring sites are shown in Figure 1. These have been selected to present a range – from bush-clad headwaters (e.g. Sites P and A) through to rural (e.g. Site F), rural/urban fringe (e.g. Site G) and urban (e.g. Site I), from the four main freshwater streams in the PTS area – the Waikumete, Oratia, Swanson and Opanuku streams.

PTS Monitoring Sites and Restoration Areas

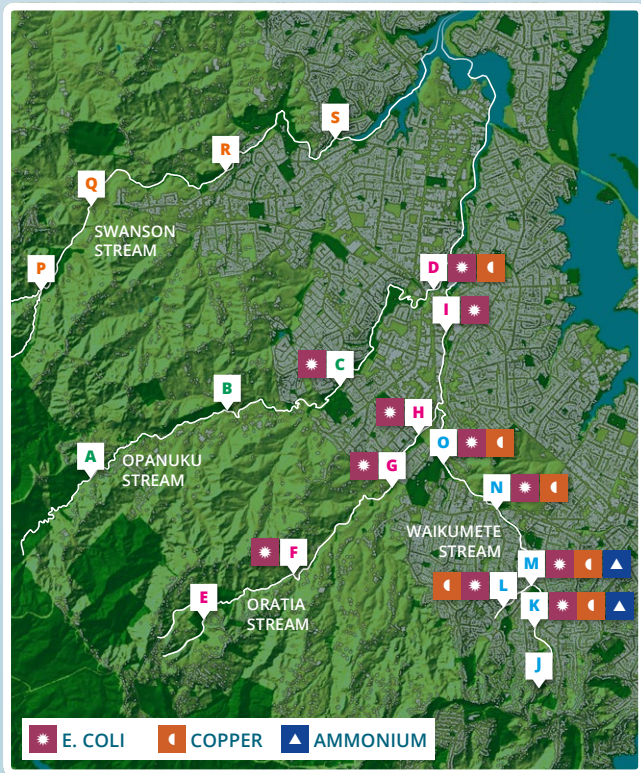
FIGURE 2: Water sampling locations that exceeded guidelines for stream health

Overall, urban streams had the worst water quality – particularly Waikumete Stream which directly relates to the higher pressures this catchment is under. Copper concentrations were exceeded at five of the nine urban sampling sites indicating a clear urban influence on the streams.

Eleven of the 19 sites exceeded the *E.coli* guideline. *E.coli* is a species of bacteria that indicates faecal pollution (animal or human) and suggests other disease-causing organisms may also be present. This bacteria may come from sewage (wastewater) overflows, runoff from pastoral farmland and/or wildlife living in and around water bodies.

The ammonia guideline was exceeded at two Waikumete sites (M and K) and, like *E.coli*, is likely linked to wastewater overflows in this area. Note that two Swanson sites (R and S) may have exceeded the *E.coli* guideline, but not enough testing was done to confirm this.

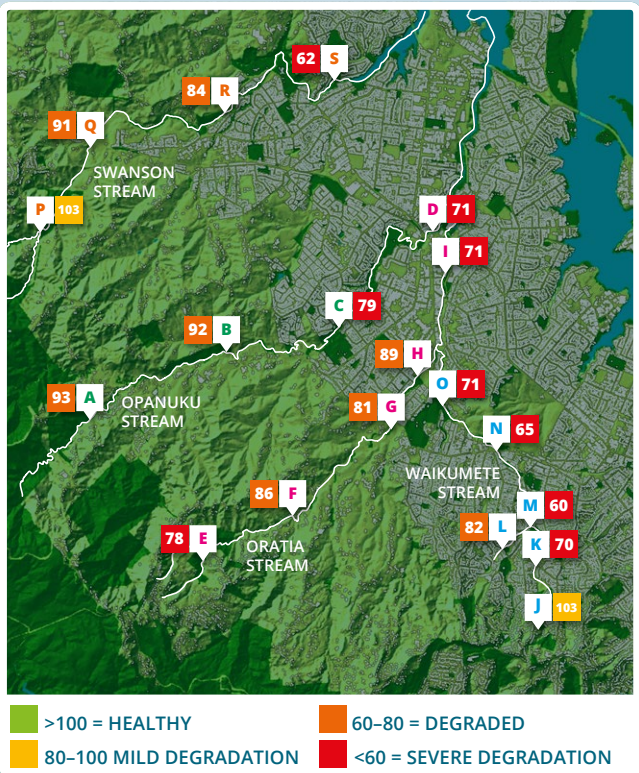
FIGURE 3: Macroinvertebrate Community Index values at each of the monitoring sites

Every invertebrate species is given a score between 1 and 10 based on their known tolerance to pollution. Biologists use this to calculate the 'Macroinvertebrate Community Index' (MCI). High MCI scores (over 120) indicate *very good* water quality, while MCI scores below 80 indicate *probable severe pollution*.

Figure 3 shows that MCI scores were generally higher at upstream sites, although no sites scored in the highest category. That may have been because samples were taken in dry, warm conditions in early April (there is a seasonal impact on MCI values with better scores in winter than in summer). Again, the Waikumete Stream system had the poorest overall ecological quality. Only two sites showed any real change. Site L in Waikumete has shown some improvement which may be related to stream bank planting. Site E in the upper part of the Opānuku has declined.

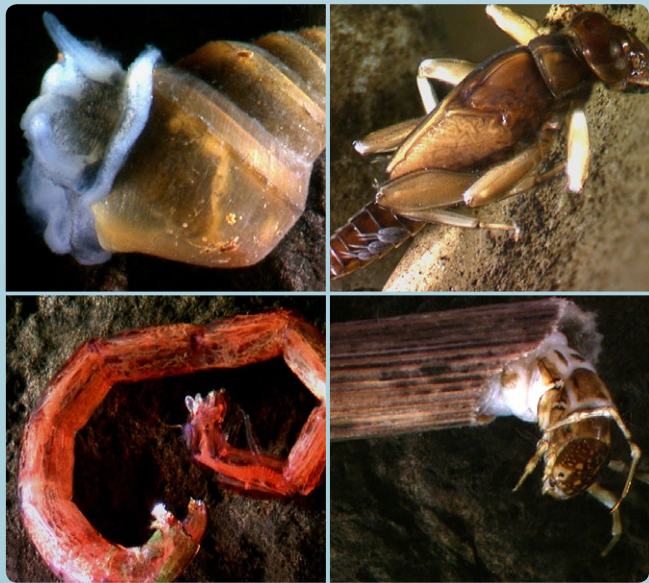
Magnified photos of common macroinvertebrates found in PTS streams

Aquatic invertebrates (small organisms without backbones) are often used as indicators of water and habitat quality because they show different sensitivity to pollution and changing stream conditions. Mayflies, stoneflies and caddisflies for e.g. are intolerant of poor quality water so their presence indicates a healthy stream.
